**REPORT ON THE CONDITION OF THE
LINESMAN'S HUTS ON THE FIFTEEN MILE
SPUR**

December 1999

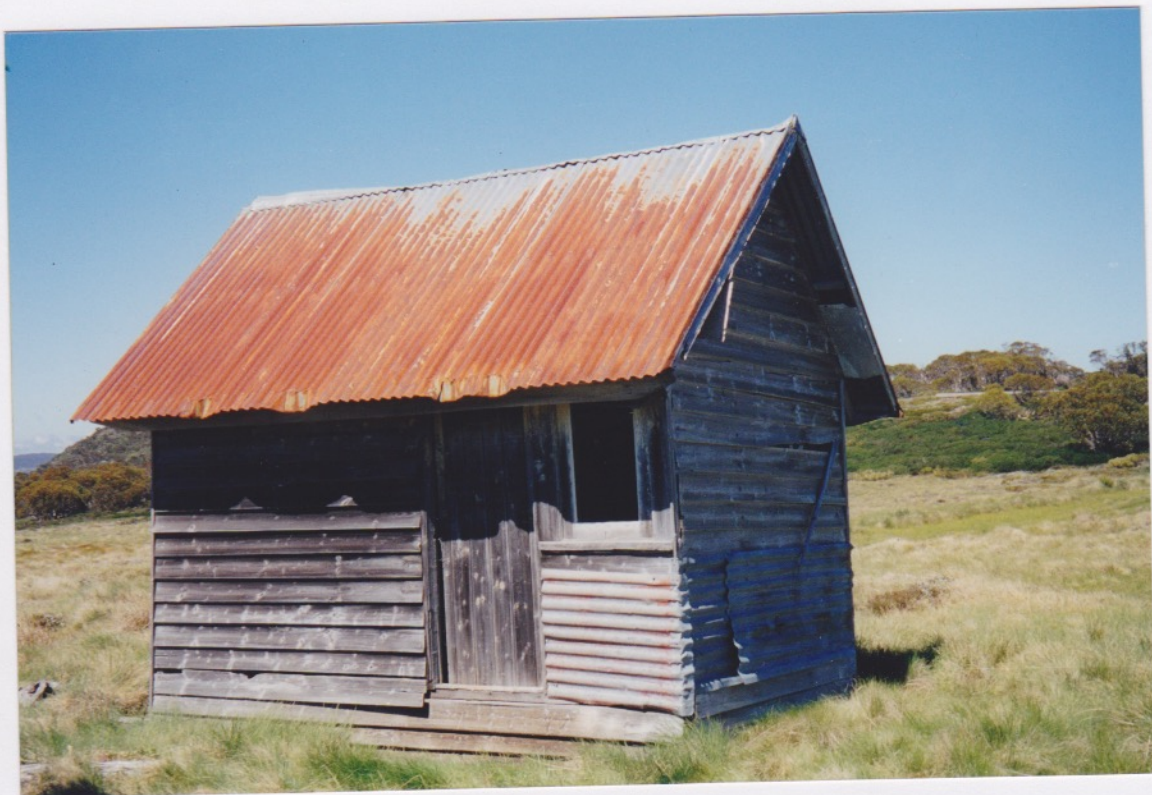
Photograph A

The two huts on Fifteen Mile Spur (GR 260134 Khancoban 1:50 000) are situated on a very exposed part of the ridge and orientated east/west. The most westerly hut (from now on referred to as Hut 1) is shown in photograph A below.

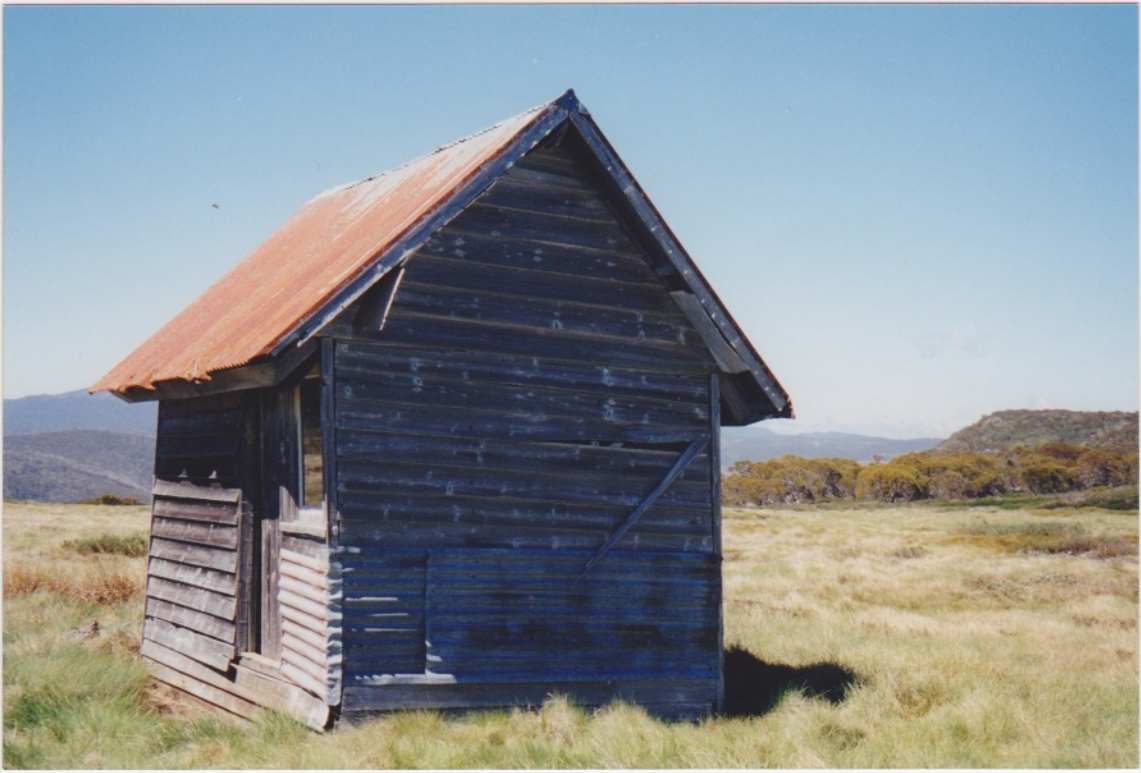
Photograph B

- the weather board cladding needs replacing on the northern wall and the lower northern end of the eastern wall
- where the weather boards are missing they have been replaced with iron sheeting (see photograph B)
- the roof appears to be sound but leaking in a number of spots
- the soffit lining has rotted out (see photograph C)
- the structure is sitting on two 100mm x 150mm x 5m wooden beams which are currently sound but are sitting in a bog (see photograph D)
- the north western corner of the hut is subsiding and twisting the framework of the hut (see photograph E)
- the internal masonite lining is rotting (see photograph F)
- A box covering a ventilation hole on the southern wall is rotting (see photograph E)
- The external cladding was once cream and is need of either repainting or oiling

REPAIR	MATERIALS REQUIRED
Repair roof	4 x 1.8 sheets of roof iron 4 litres of rust neutraliser 4 litres of slate grey roofing paint 1 x tube of silicon sealer
Replace and repair weatherboard	90 x lin m of 165mm weaterboard 3 kg of nails
Replace internal lining	60 x square metres of masonite sheeting 20m cover strips 50mm 2 kg of nails
Replace sofit lining	16 metres of 450mm fibro sofit lining 1kg of clouts
Replace and repair studs	2x 50 x 50 x 2.7m hardwood studs
Paint or oil for two coats for external cladding	Amount suitable for 100 square metres

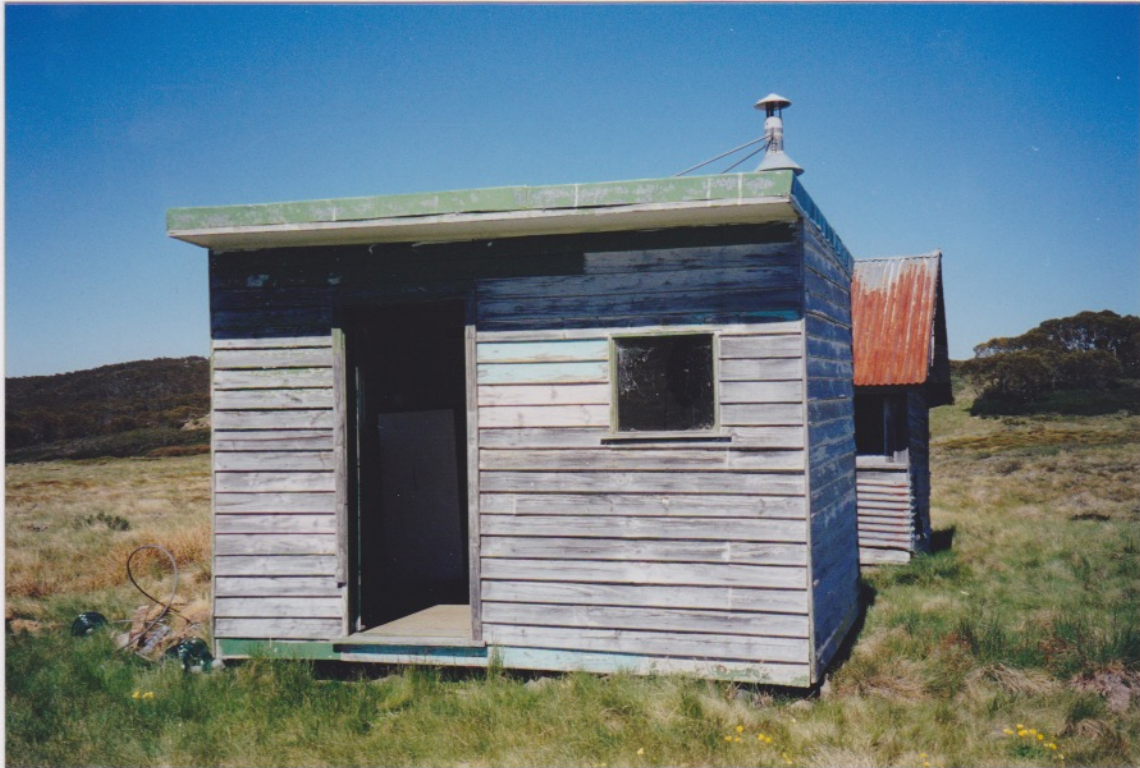
Photograph G

The most easterly hut (Hut 2) is a skillion roofed hut in far better condition than Hut 1. It is a weather board structure of more recent vintage than Hut 1 and can be seen below in Photograph G.

- the paint on the external cladding is badly weathered (see photograph G)
- the roof appears to be sound but leaking in a number of spots
- the lining in the ceiling has rotten out (see photograph H)
- the wood stove has been removed(see photograph I)
- The internal cladding was once cream and is need of repainting.

REPAIR	MATERIALS REQUIRED
Repair roof	1m of flashing 1 tube of silicon sealer
Replace internal lining	12 square metres of masonite sheeting 2 kg of nails 12 m of 50mm cover strip 18 metres of quad
Repaint interior (fawn)	Amount suitable for 100 square metres
Paint for two coats for external cladding (heritage green)	Amount suitable for 100 square metres 4 litre x paint stripper
