SOIL CONSERVATION IN ALPINE CATCHMENTS

**D. P. CLOTHIER, H.D.A.,
SOIL CONSERVATIONIST, COOMA**

**R. W. CONDON, B.Sc.AGR.,
SPECIAL SOIL CONSERVATIONIST, SYDNEY**

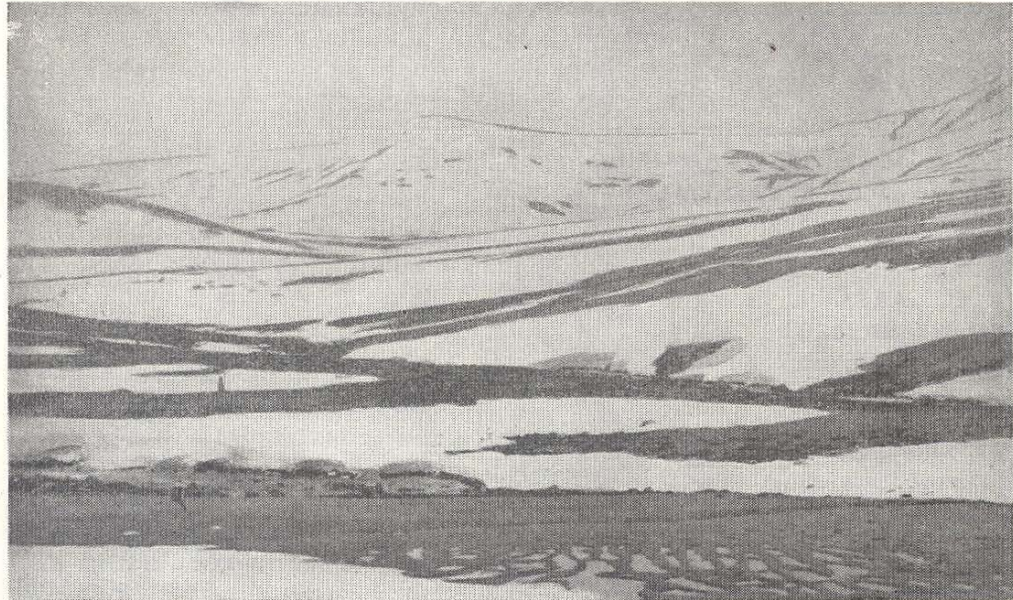
Figure 2.—The limited area of snow-fed catchments of the Australian Alps must be maintained in a stable condition to ensure optimum development of the nation's water resources

The Australian Alps which include the headwaters of the Snowy, Murray, and Murrumbidgee river systems, comprise the nation's major snow-fed catchments (figure 1). In a continent as dry as Australia, the optimum development of the nation's resources will eventually be limited by the availability of water and will require that the limited area of snow-fed catchments be maintained in a stable condition (figure 2).

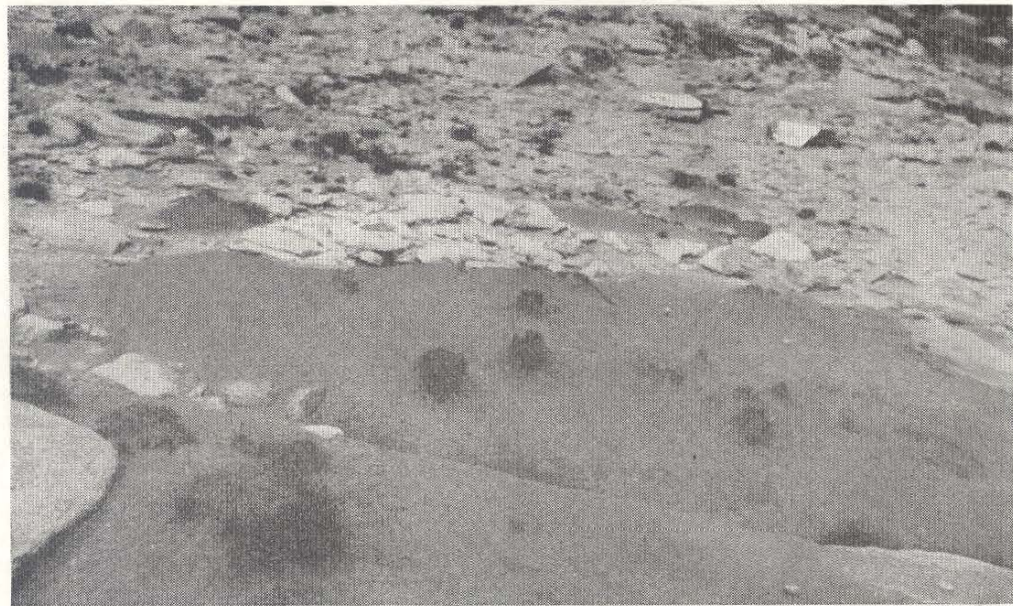
Figure 3.—Severe sheet erosion down to rocky pavement shows the small remnant of sub-soil with pedestalled plants struggling to survive—Mt Twynam

Severe sheet erosion represents the third stage, where areas suffering from moderate sheet erosion have joined up to form large areas up to several acres extent, from which as much as 2 feet of soil may be lost. The worst of this erosion is concentrated in the area between Carruthers' Peak and Mt Twynam, at elevations ranging from 6,500 feet to 7,200 feet. In this locality, individual areas of several acres have lost from 1 to 2 feet of soil, exposing large rocks and boulders to form an erosion pavement (figure 3).

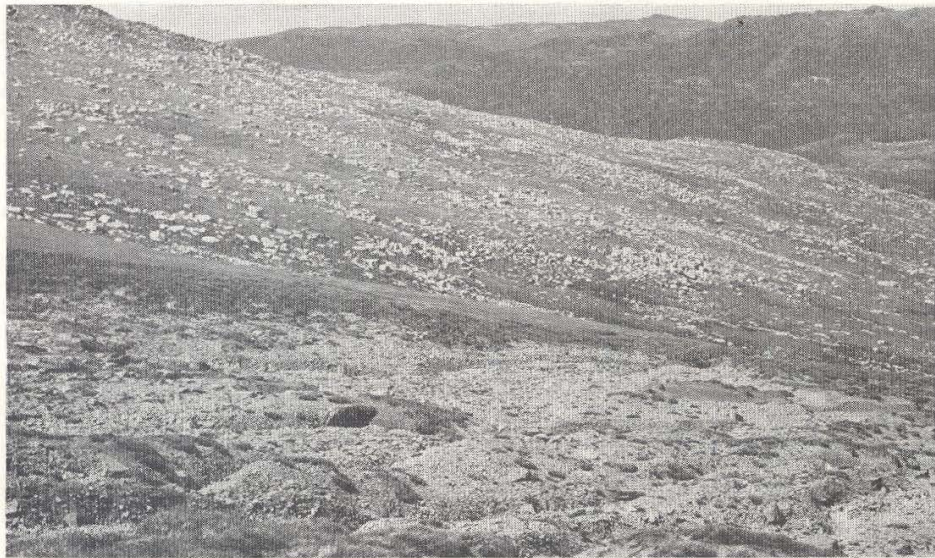
Figure 5.—Extensive area of sheet erosion from which 2-3 feet of soil has been removed, exposing boulders and a stony erosion pavement—Mt Twynam

There are now hundreds of acres from which 2-3 feet of soil have been removed, exposing boulders and a stony sub-soil or erosion pavement (figure 5). When individual areas become large the concentrated run-off results in gulying which is normally rare in alpine areas.

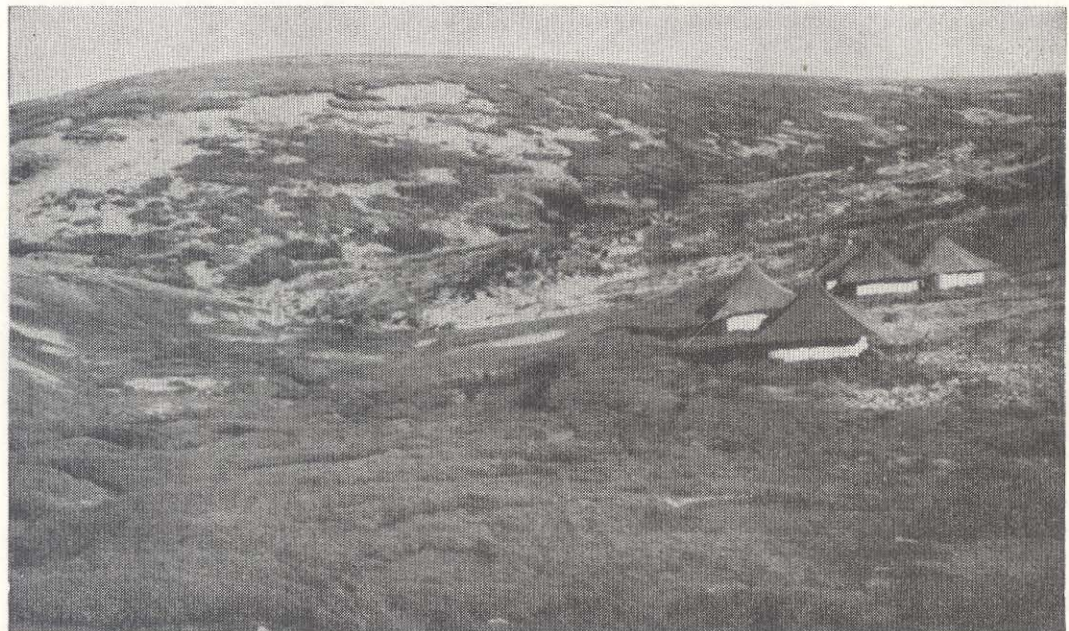
Figure 7.—The tent camp which was established on one of the relatively few flat sheltered areas below Carruthers' Peak. It was subsequently destroyed in a storm in February, 1957. The serious erosion shown in the background has now been stabilized.

Early in 1957 the first species and fertilizer trials were implemented in the Carruthers' Peak area with the object of determining the requirements necessary for successful stabilization of eroded areas. To carry out this work a tent camp (figure 7) was established on one of the relatively few flat sheltered areas below Carruthers' Peak. A violent thunderstorm struck early one February morning in 1957 leaving the camp in a shambles and forcing the work team to trudge through the storm-lashed pre-dawn to security at the Spencer's Creek weather station. Subsequently, experimental soil conservation work was confined to more accessible areas pending construction of more secure accommodation.

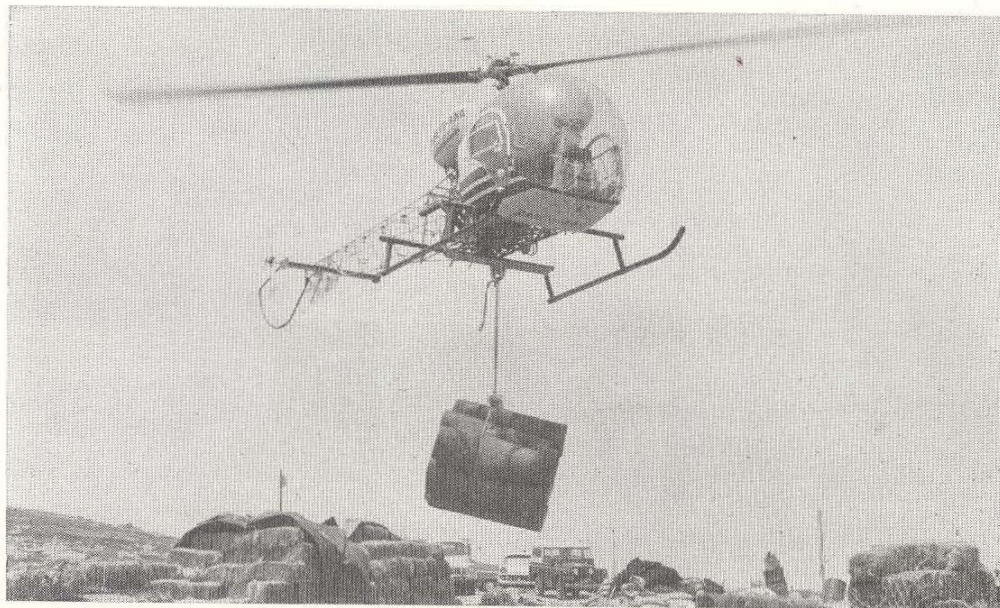
Figure 9.—Sling load of wire netting being transported by helicopter to Carruthers' Peak

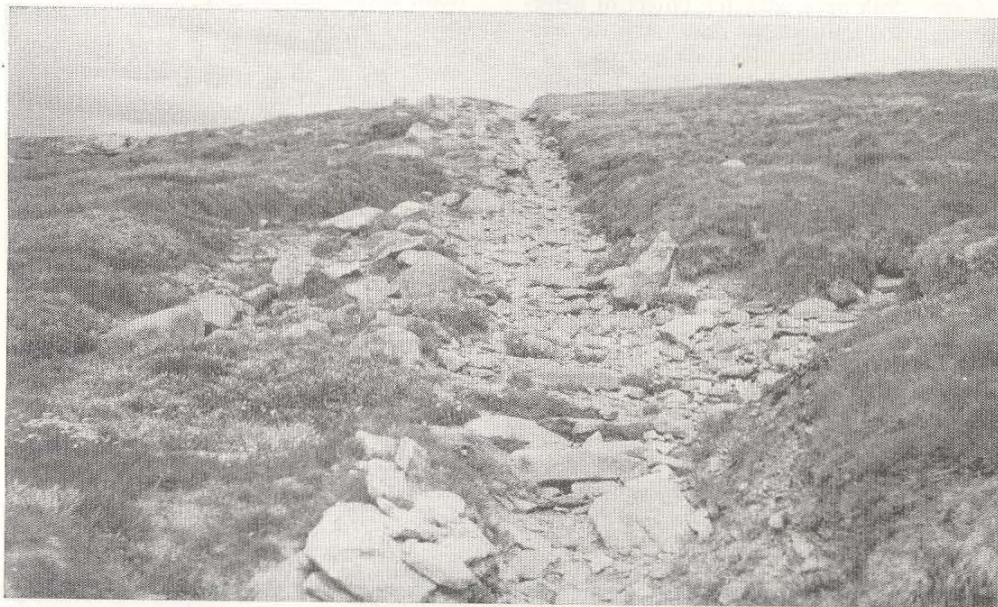
Figure 10.—Seriously gullied section of the Blue Lake track on the ridge down to Carruthers' Creek

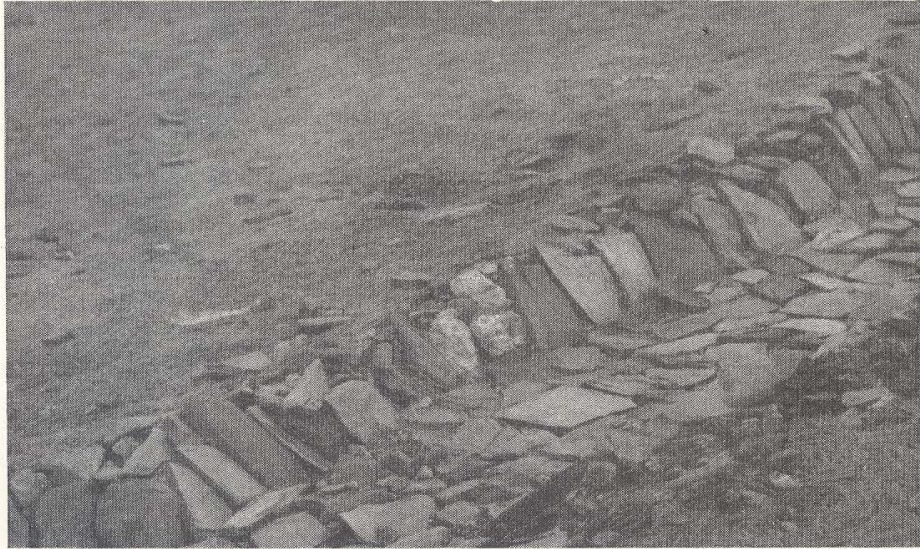
Figure 12.—The application of mulch and holding it down with netting is essential to provide suitable conditions for germination and establishment; paved drains are used for safe disposal of run-off

Run-off from the banks was discharged where possible on to existing native vegetation. Where this has not been possible, rock-paved drains have been constructed to carry water directly downslope through eroded areas to the nearest stable drainage line. These drains have normally been constructed by shaping existing small gullies and lining the sides and floor with local large flat stones. These have been most successful in handling storm flows, spaces between the rocks on the floor being filled with coarse sand carried as sediment by storm flows. Small sections have occasionally been damaged by excessive flows following storms. Providing these are repaired promptly the channels continue to function efficiently (figure 12).

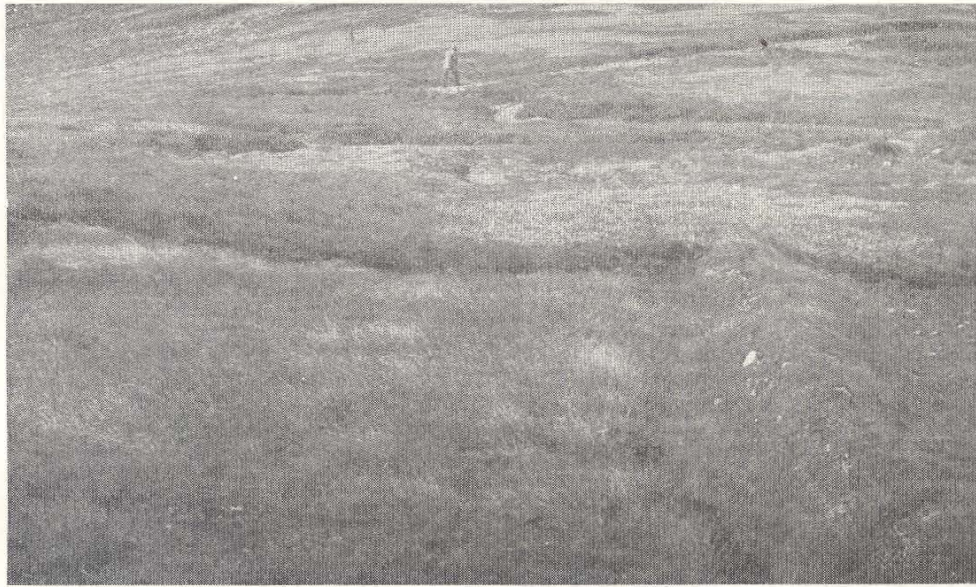
Figure 14.—Excellent vegetative cover stabilizing a formerly eroded area in the vicinity of the Blue Lake track, below Carruther's Peak. Invasion by native species is taking place
